## Mining machine parts restoration by laser surfacing

### Abstract

**Introduction.** The main reason for mining equipment failure is parts wearing out. Their effective repair requires advanced process flows. In the aircraft industry, for example, nickel-based alloys are widely used due to good mechanical properties. They should be considered for mining machine parts repair.

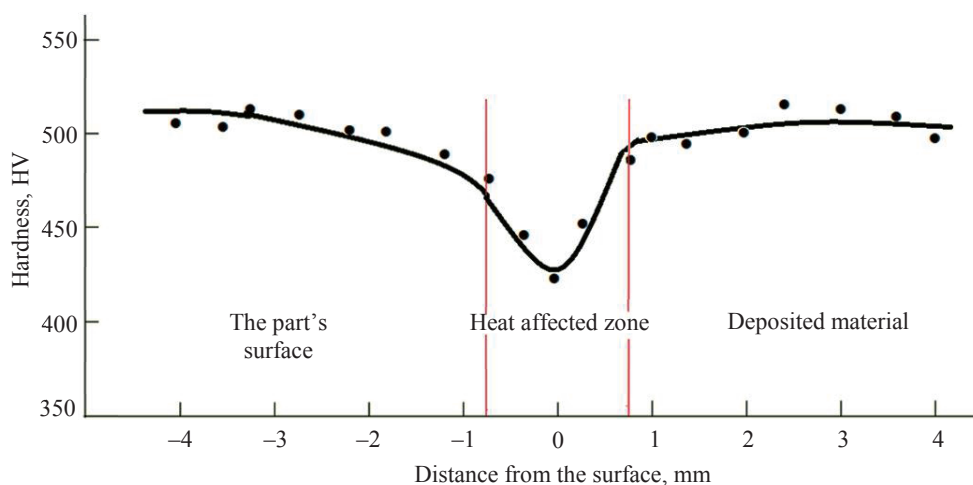
Figure 1. Hardness distribution along the depth of the sample  
Рисунок 1. Распределения твердости по глубине образца

*Microhardness test result.* The result of the deposited sample microhardness test is shown in Figure 1. The boundary between the deposited layer and the surface of the part was taken as the reference point 0 along the  $x$  axis. Hardness was measured from the outer surface into the depth of the sample on a cross-section with 0.5 mm spacing. The microhardness of the Inconel 718 deposited layers and the surface of the part have similar values (about 520 HV).
